LAKE PAHO DAM

MERCER COUNTY, MISSOURI

MO 10108

PHASE 1 INSPECTION REPORT NATIONAL DAM SAFETY PROGRAM

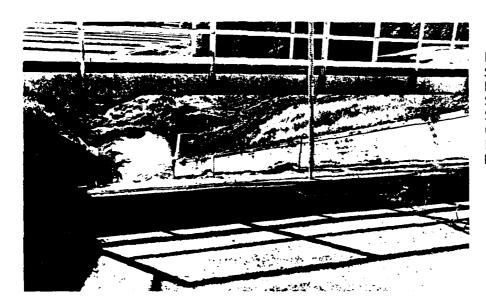
PHOTO NO. 3
SPILLWAY
LOOKING DOWNSTREAM. NOTE
SPALLING OF
CONCRETE AND
DOWNSTREAM
BANK EROSION

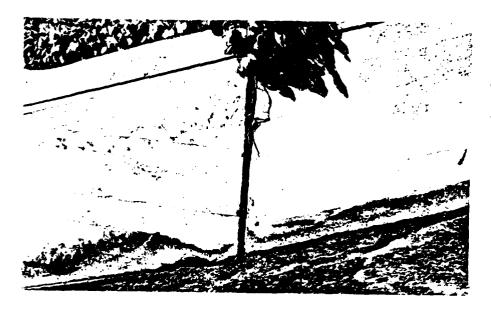
PHOTO NO. 5 EXPANSION JOINT J-4 (LOWEST JOINT) JOINT OPEN APPROX. 1/2 INCH

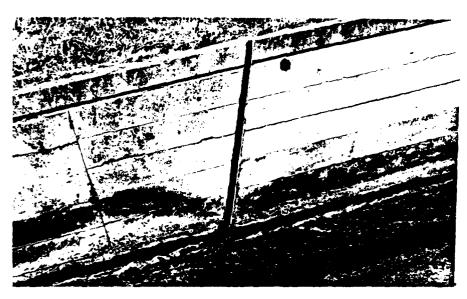
PHOTO NO. 6
EXPANSION JOINT
J-3 (RIGHT SIDE)
JOINT OPEN APPROX.
1/2 INCH. 3" X 3"
HOLE AT BOTTOM
OF JOINT

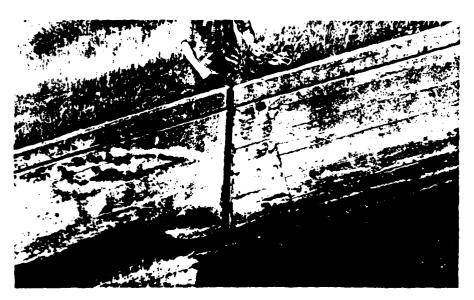
PHOTO NO. 7 EXPANSION JOINT J-2 (RIGHT SIDE) JOINT OPEN APPROX. 1/2 TO 3/4 INCH

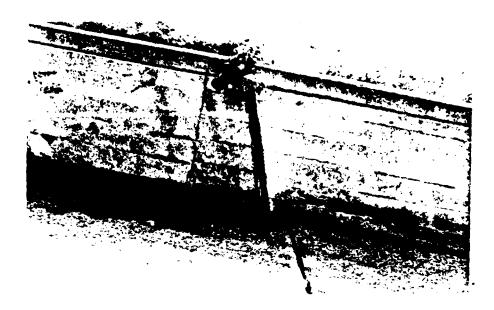
PHOTO NO. 8 EXPANSION JOINT J-2 (LEFT SIDE)

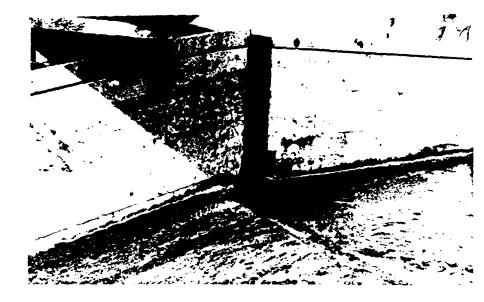
PHOTO NO. 9
EXPANSION JOINT
J-1 (RIGHT SIDE)
NOTE APPROX.
6" X 6" HOLE AT
BOTTOM OF JOINT

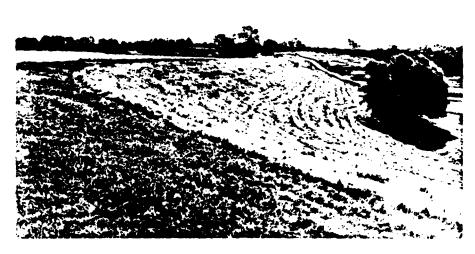
PHOTO NO. 10 LOOKING EAST ALONG CREST

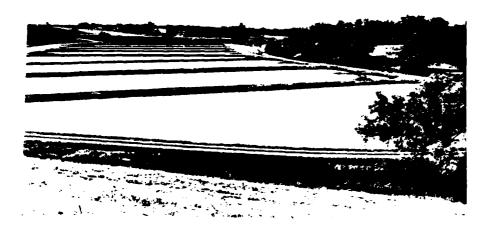
PHOTO NO. 11 FISH REARING PONDS DOWN-STREAM

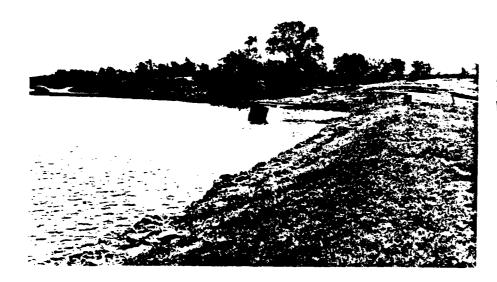
PHOTO NO. 12 UPSTREAM FACE AND OUTLET TOWER FROM WEST

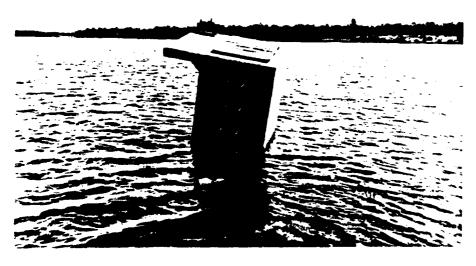
The control or inlet tower for this system is tilted about 10 degrees off of vertical towards the left (east) and downstream (south) as shown in photo No. 13. It was reported that this vertical deformation was caused by ice the first year after installation. A plan view and cross section of this system is shown in Appendix C.

PHOTO NO. 13 OUTLET TOWER FROM SOUTH

It was reported that this system is to be replaced in the near future. Asbestos/concrete pipe was on-site for the new system at the time of the inspection.

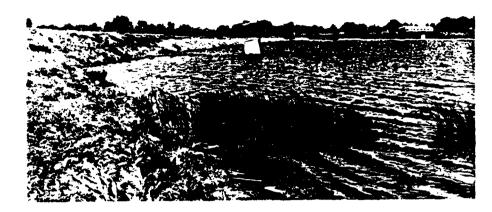
PHOTO NO. 14 UPSTREAM SLOPE FROM EAST END

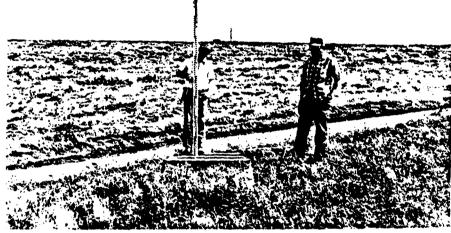
PHOTO NO. 16 SEEPS ALONG TOE OF DAM LOOKING WEST FROM EAST END

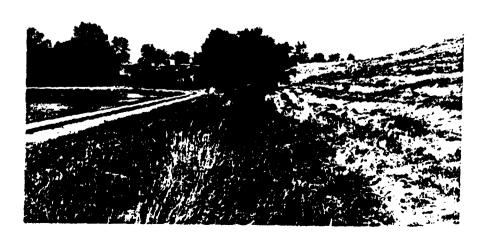
PHOTO NO. 17 SEEP AT TOE WEAR CENTER OF DAM. FISH REARING PONDS WATER LEVEL IS 0.6' LOWER THAN SEEP

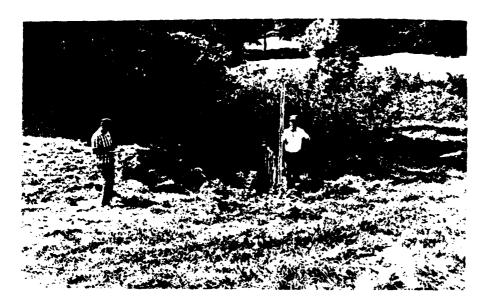
PHOTO NO. 18 ORIGINAL SPILLWAY THAT HAS BEEN PLUGGED

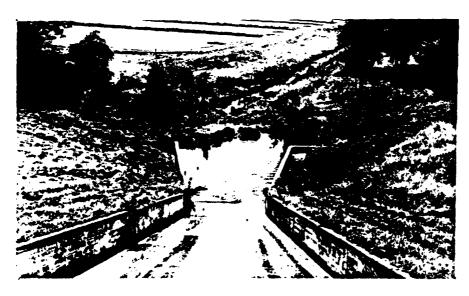
PHOTO NO. 19 SPILLWAY CHUTE OUTLET CHANNEL AND FISH REARING PONDS

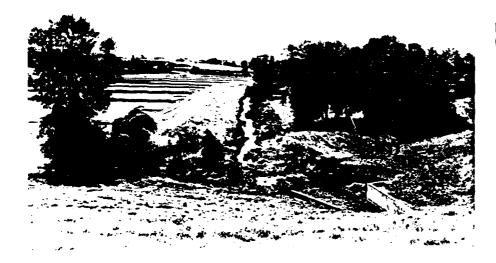
PHOTO NO. 20 OUTLET CHANNEL

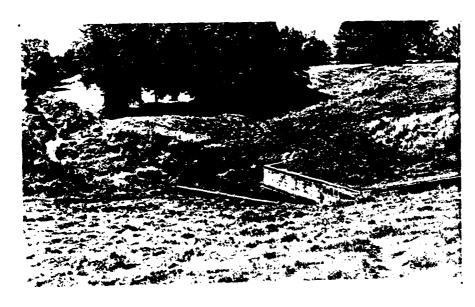
PHOTO NO. 21 EROSION AT RIGHT SIDE OF SPILLWAY STILL-ING BASIN

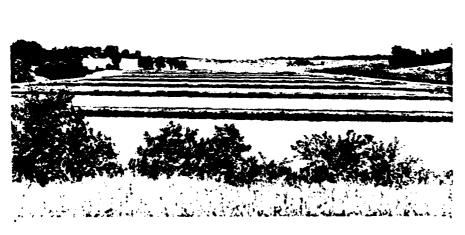
PHOTO NO. 22 LOOKING UPSTREAM ACROSS FISH REARING PONDS TO DAM. PHOTO TAKEN FROM HIGHWAY 136.
